June 20, 1977

GEORGE C. MARSHALL **SPACE
FLIGHT
CENTER**

FAILURE ANALYSIS
OF
STRUTHERS-DUNN S2GP7.25-73D
RELAY

ELECTRONIC PARTS VERIFICATION BRANCH
ELECTRONICS DEVELOPMENT DIVISION
ELECTRONICS AND CONTROL LABORATORY

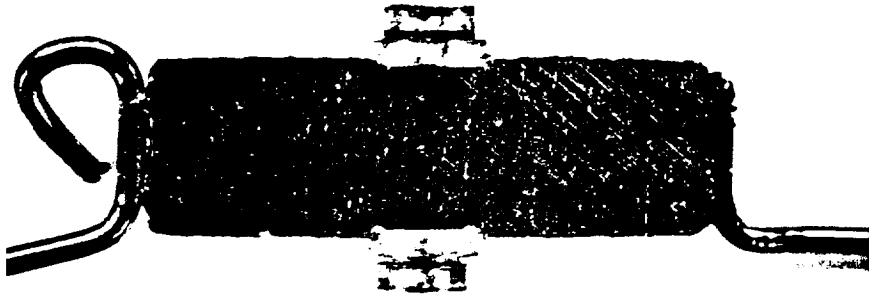
a. The armature pivot bearing engaging the back stop. Figure 2 shows the armature and pivot bearing assembly. Figure 3 shows the pivot bearing which engages the frames. This pivot bearing has a normal shape and proper undercut at the shoulder to prevent binding. Figure 4 shows the defective pivot bearing with slivers of bearing metal pushed into the undercut. Upon probing these slivers, it was noted that they were attached only on one end and were free to move.

Figure 2. Armature of Failed Relay

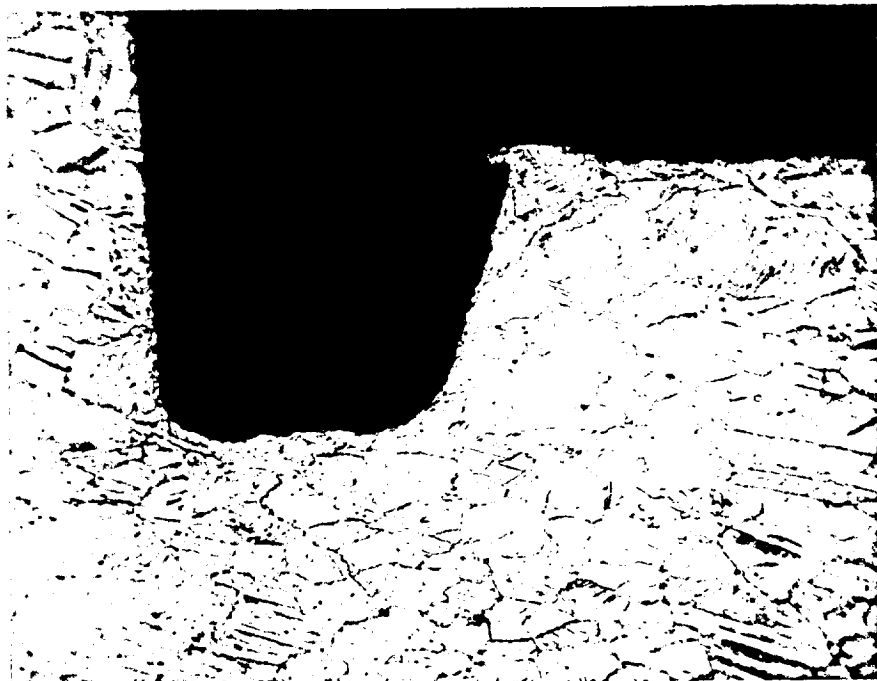
The armature was mounted so that a cross-section could be made to show the undercut in the pivot bearings. Figure 5 shows the cross-section of the pivot bearing with the normal undercut. Figure 6 shows the defective pivot bearing cross-section. Figures 7 and 8 are magnifications of the undercuts of the pivot bearing after etching to show the grain structure.

Figure 7. Magnification of Undercut Cross-section of Normal Pivot Bearing of Relay Armature After Etching (300X)

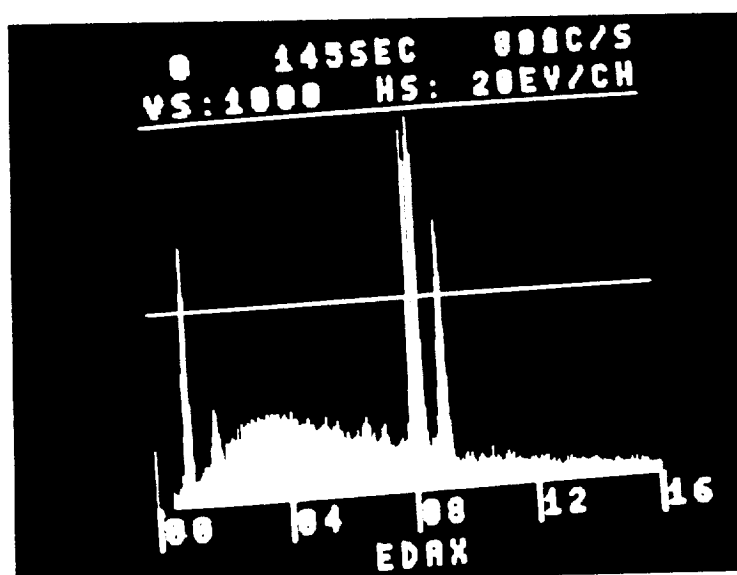
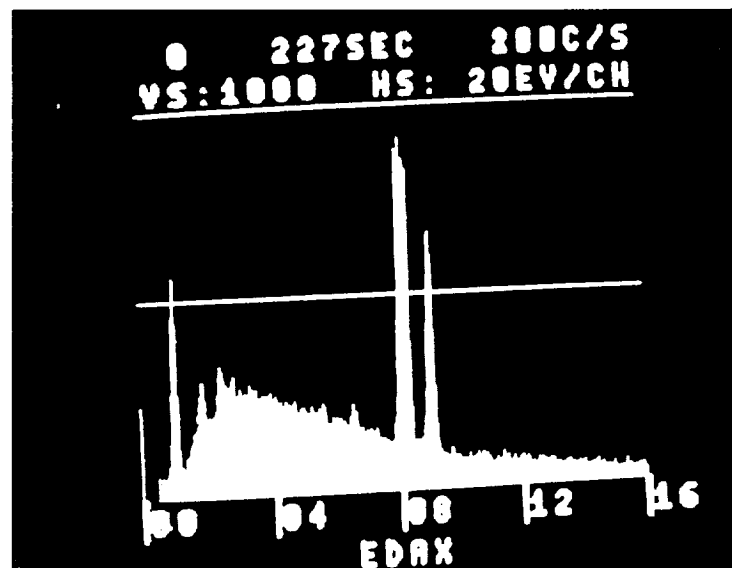
The defective pivot bearing and a sliver were subjected to EDAX X-ray analysis to verify that the sliver was the same material as the pivot bearing. The X-ray spectra of both the pivot bearing and the sliver were identical, figures 9 and 10, thus verifying that the slivers were from the pivot bearings.

Figure 9. EDAX Analysis of Pivot Bearing

Figure 10. EDAX Analysis of Metal Sliver

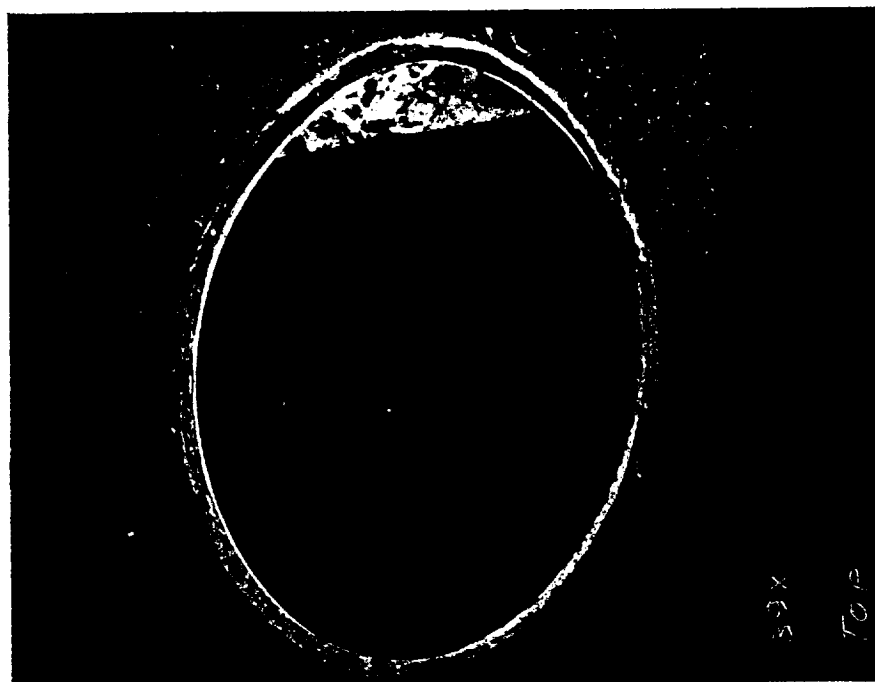
b. The back stop holes showed evidence of burrs which could cause binding. This condition is shown in figures 11, 12, and 13. Figures 14 and 15 show a deburred hole which was on the frame.

Figure 11. Armature Side of Bearing Journal of Defective Pivot Bearing (39X)

Figure 12. Armature Side of Bearing Journal of Defective Pivot Bearing (50X)

Figure 13. Magnified View of Armature Side of Bearing Journal of Defective Pivot Bearing (160X)
